**Flood Control Project Maintenance
Levee Inspections****LMA District Cover Sheet
Spring 2014 Levee Inspection Results****Reclamation District No. 2058 Pescadero**

Spring 2014 Levee Inspection Results

Reclamation District No. 2058 Pescadero

Waterway			Bank	Unit Miles
Unit No. 01 Paradise Cut			Left	6.71
	Spring (March - May)	Summer (June - August)	(September - November) Fall	Winter (December - February)
Unit Maintenance Rating (Fall Only)				
Date of Inspection	05/06/2014 - 05/06/2014			
DWR Inspector	Maksim Khashchuk			
Accompanied By	Greg Pombo RD2058			
	Michael McManus RD2058

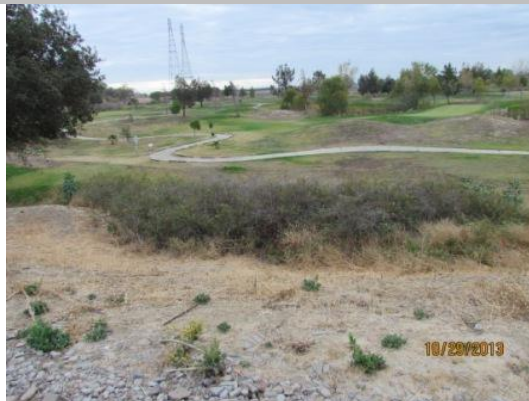
Photo 1 of 1 : mkhashch_s_20140428_00599.jpg

LM Start	0.23	Rating **	A/W	Issue No.	4
LM End	0.23	Issue Type +	Ob	Location *	LS
Category	Earthen Levee			GPS Latitude/Longitude	
				Start	End
Item	Vegetation			37.804351 °	37.804351 °
				-121.418433 °	-121.418433 °
DWR ID	DWR_RD2058_01_f_2013_4				
Action/Comments					
Environmental Requirements.					
Inspector Comments: Wild rose brush rabbit habitat.

View of the wild rose habitat for the brush rabbit.

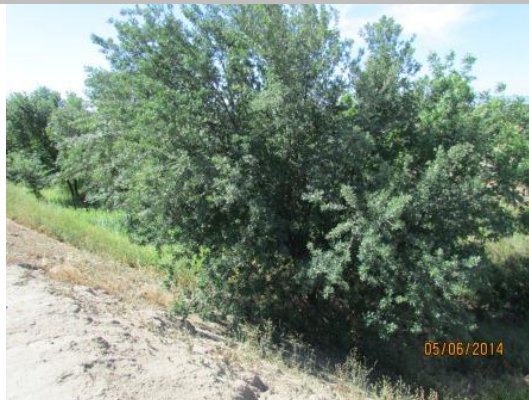
Photo 1 of 1 : mkhashch_s_20140512_00980.jpg

LM Start	0.50	Rating **	M	Issue No.	301
LM End	0.50	Issue Type +	Ma	Location *	LS
Category	Earthen Levee			GPS Latitude/Longitude	
				Start	End
Item	Trim / Thin Trees			37.802932 °	37.802932 °
				-121.414652 °	-121.414652 °
DWR ID	DWR_RD2058_01_s_2014_301				
Action/Comments					
Trim trees to at least five feet above ground level.

View of the trees at the landside levee toe obstructing visibility and access.

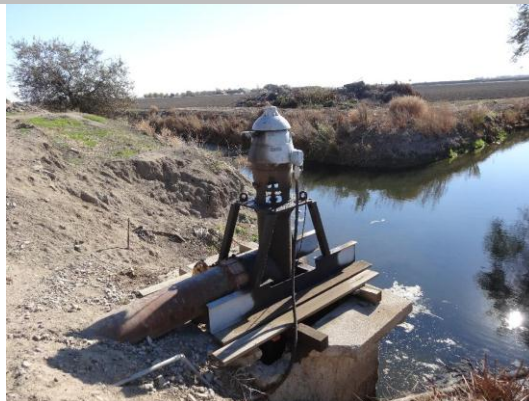
Photo 1 of 1 : UCIP_4415.jpg

LM Start	0.73	Rating **	M	Issue No.	296
LM End	0.73	Issue Type +	En	Location *	LS
Category	Supplemental			GPS Latitude/Longitude	
				Start	End
Item	DWR UCIP Field Study			37.801792 °	37.801792 °
				-121.410921 °	-121.410921 °
DWR ID	DWR_RD2058_01_s_2014_296				
Action/Comments					
Inspector Comments: FS_ID:25045					
EP_NO: 5055					
Repair Type:					
Crossing Status:					
UCIP Comments: Soil erosion around siphon breaker. Siphon breaker lid/cover damaged and displaced. No pump house on landside. Pump on concrete sump on landside.					
FIELD_STRUCT_DESC: 16-inch steel pipe through levee 3.8 feet below crown. Pump on concrete sump on landside. Siphon breaker on the waterward slope (Permit No. 5055, 1666).					
FS Date: 12/5/2013

LS view: exposed pipe and vertical pump on concrete sump on drain ditch.

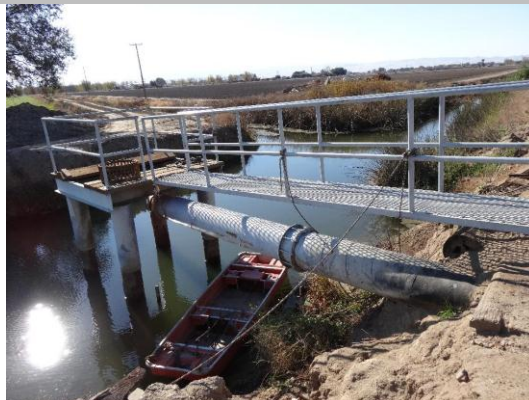
Photo 1 of 1 : UCIP_4419.jpg

LM Start	1.24	Rating **	M	Issue No.	297
LM End	1.24	Issue Type +	En	Location *	LS
Category	Supplemental			GPS Latitude/Longitude	
				Start	End
Item	DWR UCIP Field Study			37.802301 °	37.802301 °
				-121.401977 °	-121.401977 °
DWR ID	DWR_RD2058_01_s_2014_297				
Action/Comments					
Inspector Comments: FS_ID:25049					
EP_NO: N/A					
Repair Type:					
Crossing Status:					
UCIP Comments: Siphon breaker and pump removed for repairs					
(Richard). Pipe seems corroded.					
FIELD_STRUCT_DESC: 18-inch steel pipe through levee unknown feet					
below crown. Pump in ditch on the landward side. Siphon breaker on					
waterside shoulder. Electrical service pole at the landward toe.					
FS Date: 12/5/2013

LS view: pipe, pile structure, and pump platform in drain ditch. Pump removed for repair.

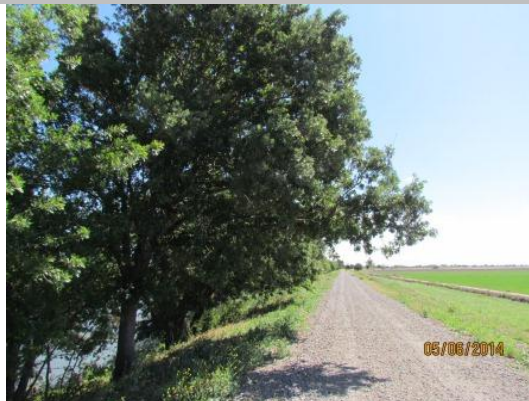
Photo 1 of 1 : mkhashch_s_20140512_00981.jpg

LM Start	1.32	Rating **	M	Issue No.	3
LM End	1.32	Issue Type +	Ma	Location *	CR
Category	Earthen Levee			GPS Latitude/Longitude	
				Start	End
Item	Trim / Thin Trees			37.802689 °	37.802689 °
				-121.400448 °	-121.400448 °
DWR ID	DWR_RD2058_01_s_2014_3				
Action/Comments					
Trim trees over roadway to at least 12 feet above ground level.

View of the low hanging tree branch over levee crown.

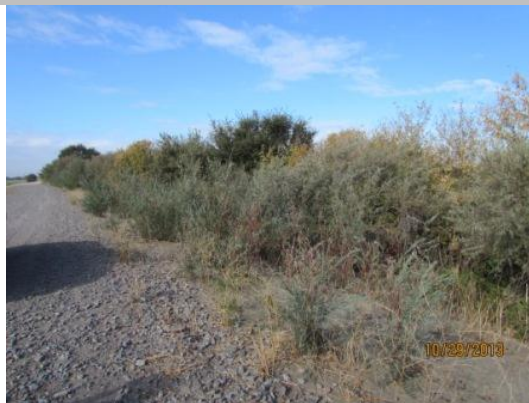
Photo 1 of 1 : mkhashch_s_20140428_00615.jpg

LM Start	1.72	Rating **	M	Issue No.	961
LM End	1.78	Issue Type +	Ma	Location *	WS
Category	Earthen Levee			GPS Latitude/Longitude	
				Start	End
Item	Vegetation			37.804333 °	37.804615 °
				-121.393657 °	-121.392588 °
DWR ID	DWR_RD2058_01_s_2012_961				
Action/Comments					
Remove the wild growth other than native grasses from the levee slopes.

View if the overgrown vegetation on the waterside slope to be removed.

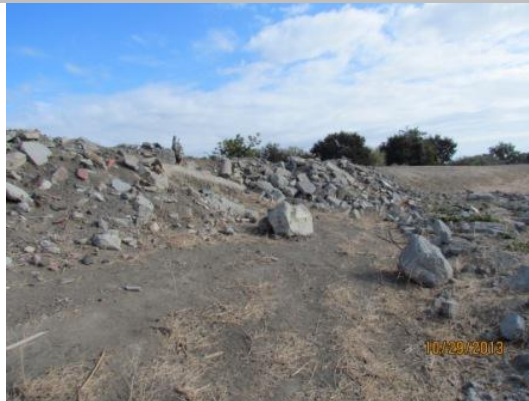
Photo 1 of 1 : mkhashch_s_20140428_00600.jpg

LM Start	1.84	Rating **	U	Issue No.	11
LM End	1.84	Issue Type +	En	Location *	LS
Category	Earthen Levee			GPS Latitude/Longitude	
				Start	End
Item	Encroachments			37.804785 °	37.804785 °
				-121.391524 °	-121.391524 °
DWR ID	DWR_RD2058_01_f_2013_11				
Action/Comments					
Material Inspector Comments: Pile of concrete contains rebar on landside slope obstructing visibility and access.

View of the concrete with rebar placed on the landside slope.

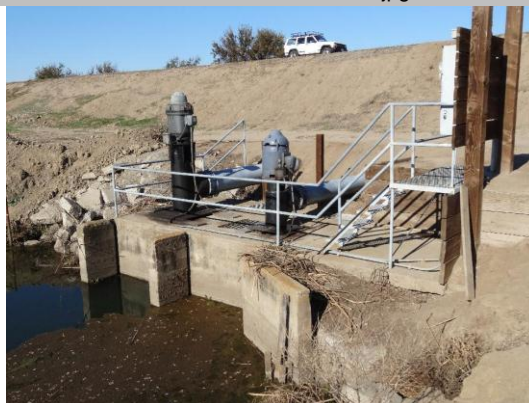
Photo 1 of 1 : UCIP_4503.jpg

LM Start	2.14	Rating **	M	Issue No.	298
LM End	2.14	Issue Type +	En	Location *	LS
Category	Supplemental			GPS Latitude/Longitude	
				Start	End
Item	DWR UCIP Field Study			37.803892 °	37.803892 °
				-121.386299 °	-121.386299 °
DWR ID	DWR_RD2058_01_s_2014_298				
Action/Comments					
Inspector Comments: FS_ID:25142					
EP_NO: N/A					
Repair Type:					
Crossing Status:					
UCIP Comments: Pump on concrete sump on drain ditch. Siphon breaker base highly corroded. Soil erosion around siphon breaker.					
FIELD_STRUCT_DESC: 20-inch pipe 8.0 feet below crown. Siphon breaker on waterside. Pump on concrete sump on drain ditch. Originally included in the 1964 O&M manual, SJR 10, March 1964.					
FS Date: 12/5/2013

LS view: pumps on concrete sump, walkway, service pole in the drain ditch.

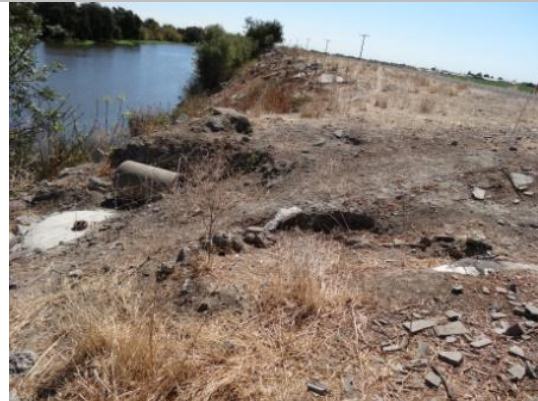
Photo 1 of 1 : mkhashch_s_20140428_00596.jpg

LM Start	2.15	Rating **	M	Issue No.	1
LM End	2.15	Issue Type +	Ma	Location *	WS
Category	Supplemental			GPS Latitude/Longitude	
				Start	End
Item	DWR Erosion Survey			37.803769 °	37.803769 °
				-121.386341 °	-121.386341 °
DWR ID	DWR_RD2058_01_s_2014_1				
Action/Comments					
Inspector Comments: 08/28/2013: No significant change observed. 07/31/2012: Site was visited on 07/26/2012. No significant change observed. A new vertical pipe was installed and concrete blocks left on the site. Dense vegetation is visible at the site. No signs of new leaks or spill from the siphon breaker. 09/02/2011: Site was not visited due to the time limit. 09/22/2010: No significant changes observed. Vegetation downstream, upstream and on the lower slope of the site have been recently sprayed. These areas were also fenced off during the site visit, making it difficult for us to examine the condition of the lower slope. Possible leak or spill from the siphon breaker is creating notches along the slope and developing into a headward erosion. If the problem continues, it will erode the slope and fully expose the pipe to outside elements. 07/23/2009: A possible leak or spill from a siphon breaker is eroding the slope and developing into a headward erosion; a portion of the buried pipe is exposed; the lower slope seems to be lined with chunks of concrete debris or other rock material. [2013 Site ID:RD2058U01RM1.78]

Direct view of siphon breaker.

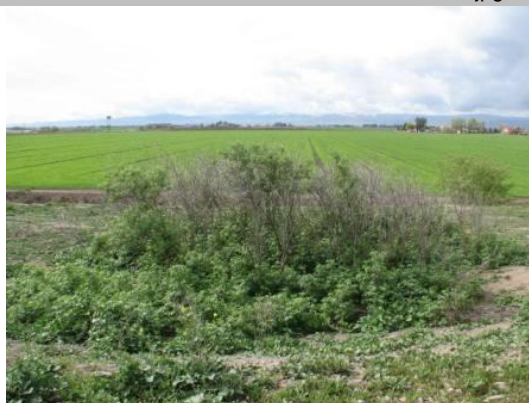
Photo 1 of 1 : mkhashch_s_20140428_00602.jpg

LM Start	2.42	Rating **	A/W	Issue No.	16
LM End	2.42	Issue Type +	Ma	Location *	LS
Category	Earthen Levee			GPS Latitude/Longitude	
				Start	End
Item	Vegetation			37.802782 °	37.802782 °
				-121.381413 °	-121.381413 °
DWR ID	DWR_RD2058_01_s _ 2012_16				
Action/Comments					
Elderberries are blocking visibility and flood fight capability. Inspector Comments: Elderberry growing on landside toe.

03/28/2012 Large elderberry bush on landside slope.

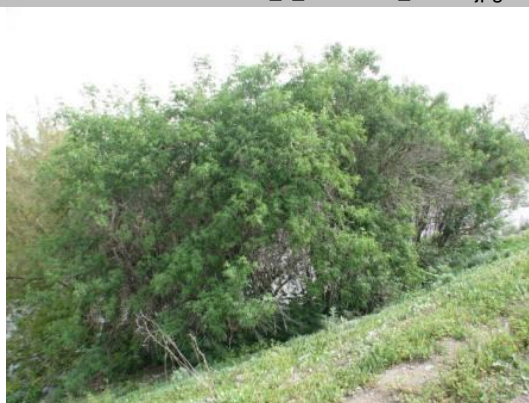
Photo 1 of 1 : mkhashch_s_20140428_00614.jpg

LM Start	2.64	Rating **	A/W	Issue No.	63
LM End	2.64	Issue Type +	Ma	Location *	WS
Category	Earthen Levee			GPS Latitude/Longitude	
				Start	End
Item	Vegetation			37.801962 °	37.801962 °
				-121.377684 °	-121.377684 °
DWR ID	DWR_RD2058_01_s _ 2012_63				
Action/Comments					
Elderberries are blocking visibility and flood fight capability. Inspector Comments: Elderberry on waterside slope.

03/28/2012 Large elderberry bush located on waterward slope.

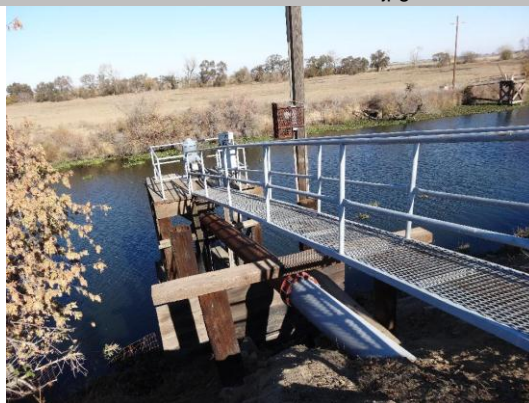
Photo 1 of 1 : UCIP_4506.jpg

UCIP Comments: Overhead power line Power pole on waterside looks new pipe installed and levee crown not compacted well . Pump house not found.

FIELD_STRUCT_DESC: 18-inch pipe through levee 8.0 feet below crown (Permit No. 3235, 1960). Pump on pile structure in the stream. Steel walkway to the pump. Timber bulkhead on the waterward slope. Concrete distribution box at the toe of the landward slope. Included in the 1964 O&M manual. Replaces 14-inch pipe at same location.

WS view: walkway, pipe, and pump on pile structure in the stream.

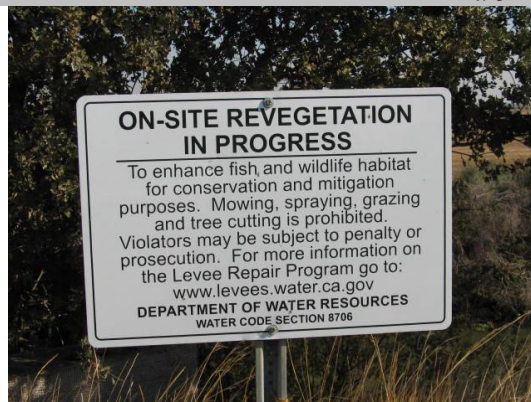
Photo 1 of 1 : mkhashch_s_20140428_00603.jpg

LM Start	3.85	Rating **	A/W	Issue No.	20
LM End	3.85	Issue Type +	Ma	Location *	WS
Category	Earthen Levee			GPS Latitude/Longitude	
				Start	End
Item	Vegetation			37.790807 °	37.790807 °
				-121.362905 °	-121.362905 °
DWR ID	DWR_RD2058_01_s _ 2012_20				
Action/Comments					
Environmental Requirements.					
Inspector Comments: Revegetation site.

11/08/2011 Revegetation site, cannot trim or cut vegetation in this area.

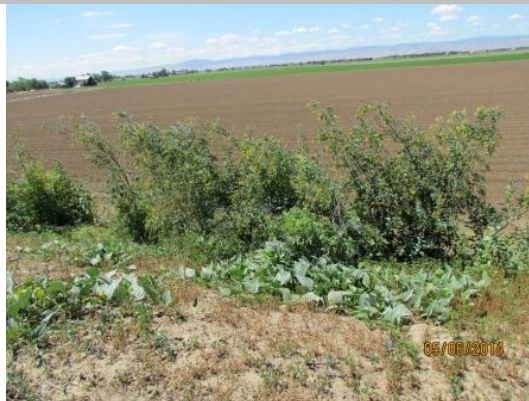
Photo 1 of 1 : mkhashch_s_20140512_00982.jpg

LM Start	3.96	Rating **	M	Issue No.	22
LM End	3.96	Issue Type +	Ma	Location *	LS
Category	Earthen Levee			GPS Latitude/Longitude	
				Start	End
Item	Vegetation			37.789434 °	37.789434 °
				-121.361721 °	-121.361721 °
DWR ID	DWR_RD2058_01_s _ 2014_22				
Action/Comments					
Remove the wild growth other than native grasses from the levee slopes.

View of the tall vegetation on the landside levee slope and toe.

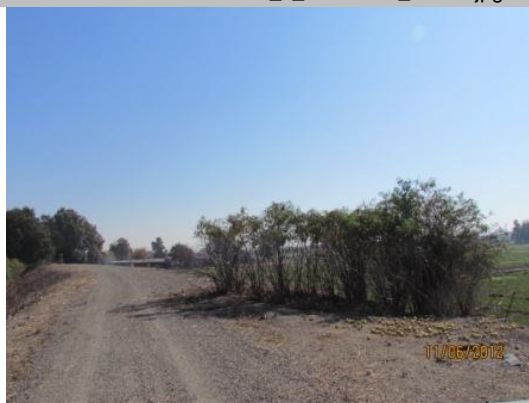
Photo 1 of 1 : mkhashch_s_20140428_00607.jpg

LM Start	4.01	Rating **	M	Issue No.	26
LM End	4.01	Issue Type +	Ma	Location *	LS
Category	Earthen Levee			GPS Latitude/Longitude	
				Start	End
Item	Vegetation			37.789128 °	37.789128 °
				-121.361042 °	-121.361042 °
DWR ID	DWR_RD2058_01_s _ 2012_26				
Action/Comments					
Elderberries are blocking visibility and flood fight capability. Inspector Comments: Elderberry on landside hinge point.

Elderberry bushes on landside slope.

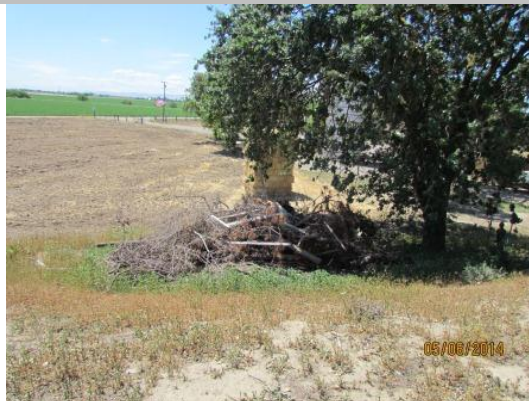
Photo 1 of 1 : mkhashch_s_20140512_00983.jpg

LM Start	4.12	Rating **	U	Issue No.	23
LM End	4.12	Issue Type +	Ma	Location *	LS
Category	Earthen Levee			GPS Latitude/Longitude	
				Start	End
Item	Encroachments			37.788833 °	37.788833 °
				-121.358962 °	-121.358962 °
DWR ID	DWR_RD2058_01_s _ 2014_23				
Action/Comments					
Debris					
Inspector Comments: Large pile of debris at landside levee toe.

View of a pile of prunings at the landside levee toe obstructing visibility and access.

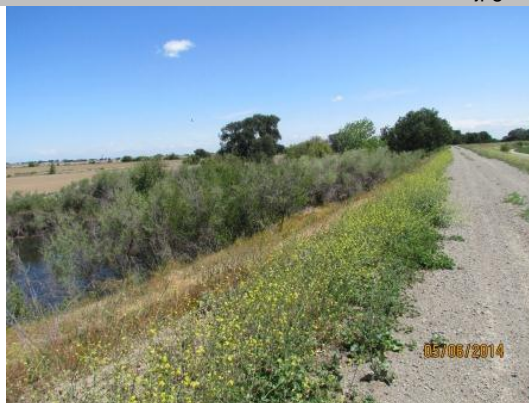
Photo 1 of 1 : mkhashch_s_20140512_00984.jpg

LM Start	4.25	Rating **	M	Issue No.	24
LM End	4.25	Issue Type +	Ma	Location *	WS
Category	Earthen Levee			GPS Latitude/Longitude	
				Start	End
Item	Vegetation			37.789267 °	37.789267 °
				-121.356835 °	-121.356835 °
DWR ID	DWR_RD2058_01_s _ 2014_24				
Action/Comments					
Control annual grass and weeds on the levee slopes and easements.

View of the annual vegetation on the waterside levee slope.

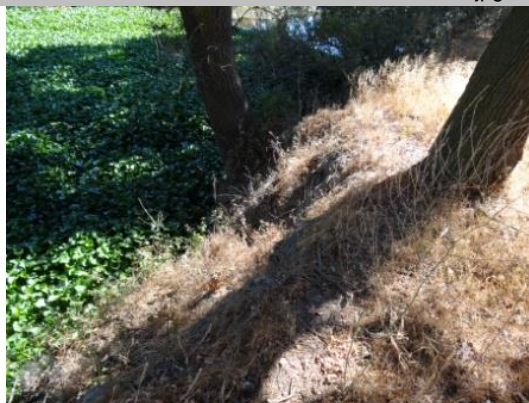
Photo 1 of 1 : mkhashch_s_20140428_00597.jpg

LM Start	4.49	Rating **	M	Issue No.	2
LM End	4.53	Issue Type +	Ma	Location *	WS
Category	Supplemental			GPS Latitude/Longitude	
				Start	End
Item	DWR Erosion Survey			37.789810 °	37.789810 °
				-121.352490 °	-121.352490 °
DWR ID	DWR_RD2058_01_s_2014_2				
Action/Comments					
Inspector Comments: 08/28/2013: No significant change observed. 07/26/2012: The site has been visited, and no significant change has been observed. 09/02/2011: This site was not visited due to the time limit. 09/22/2010: No significant changes observed. Minor pocket erosions are lined at the lower bank. Two large Oak and Willow trees are on mid-slope and bench. The remaining bench was re-measured and found to be approximately 10 feet. There was no indication of active erosion on site during the site visit. 08/05/2010: Recommended for annual assessment and monitoring of site during flood events, per CLRO. 07/23/2009: No major change observed since last visit; site is a 200-ft. long near-vertical berm erosion; recommend annual assessment and monitoring of erosion site, per CLRO CES Evaluation 2008 Report; Site # is the same site previously reported as RM4.0,LM4.51; previously rated "U". 09/10/2008: Two large trees (2-3' DBH) with partial roots exposed. 2007: Visited site 03/13/2007. [2013 Site ID:RD2058U01RM3.97]

Direct view of the erosion near a tree.

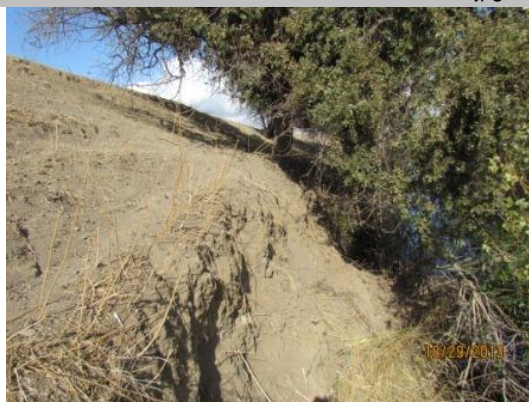
Photo 1 of 1 : mkhashch_s_20140428_00601.jpg

LM Start	4.82	Rating **	U	Issue No.	15
LM End	4.82	Issue Type +	Ma	Location *	WS
Category	Earthen Levee			GPS Latitude/Longitude	
				Start	End
Item	Erosion / Bank Caving			37.785862 °	37.785862 °
				-121.350303 °	-121.350303 °
DWR ID	DWR_RD2058_01_f_2013_15				
Action/Comments					
Note and monitor erosion site.					
Inspector Comments: The erosion has about a 3 foot vertical cut at the waterside levee toe.

View of the erosion at the waterside levee toe.

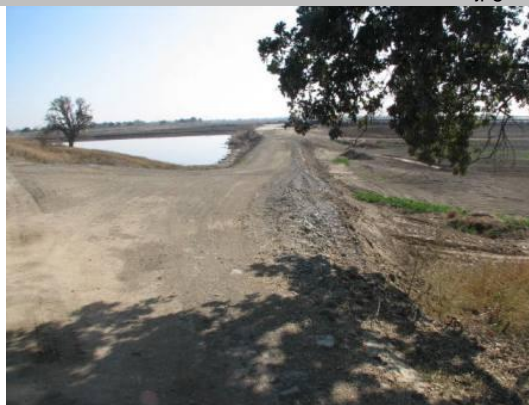
Photo 1 of 3 : mkhashch_s_20140428_00608.jpg

LM Start	5.16	Rating **	U	Issue No.	29
LM End	5.16	Issue Type +	En	Location *	LS
Category	Earthen Levee			GPS Latitude/Longitude	
				Start	End
Item	Encroachments			37.783102 °	37.783102 °
				-121.345682 °	-121.345682 °
DWR ID	DWR_RD2058_01_s _ 2012_29				
Action/Comments					
Ramp					
Inspector Comments: New ramp construction connecting dairy to levee. Construction of ramp results in a new pond on the landside of the levee. 2/21/2012, owner has said that he will contact the CVFPB to resolve this issue.

11/08/2011 New ramp has been constructed by Dairy farmer connecting his barns to the levee.

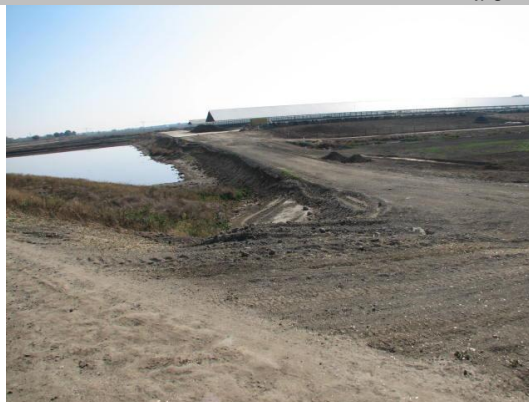
Photo 2 of 3 : mkhashch_s_20140428_00609.jpg

11/08/2011 New ramp has been constructed by Dairy farmer connecting his barns to the levee.

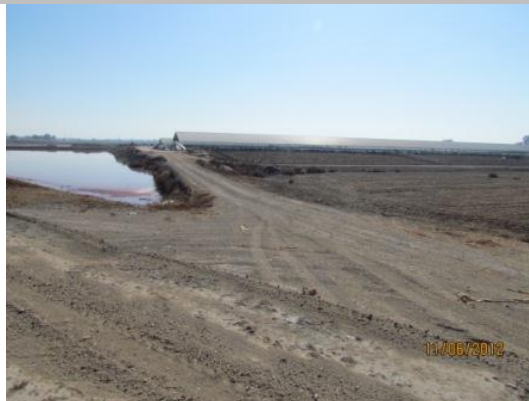
Photo 3 of 3 : mkhashch_s_20140428_00610.jpg

Completed new ramp constructed by Dairy farmer connecting his barns to the levee.

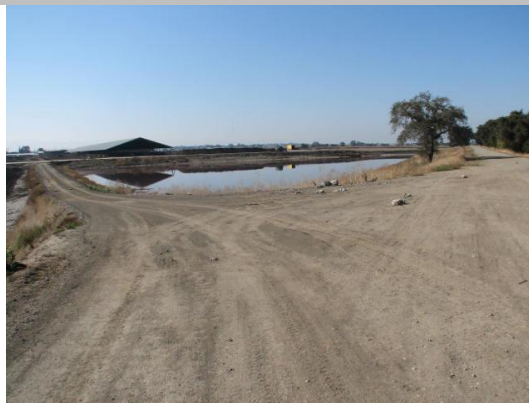
Photo 1 of 3 : mkhashch_s_20140428_00611.jpg

LM Start	5.37	Rating **	U	Issue No.	30
LM End	5.37	Issue Type +	En	Location *	LS
Category	Earthen Levee			GPS Latitude/Longitude	
				Start	End
Item	Encroachments			37.782268 °	37.782268 °
				-121.342257 °	-121.342257 °
DWR ID	DWR_RD2058_01_s _ 2012_30				
Action/Comments					
Ramp					
Inspector Comments: Ramp constructed to dairy. Raised ramps, see issue 29 are creating new holding ponds for dairy at levee toe.

11/08/2011 Photo shows existing middle ramp to the levee which has been raised.

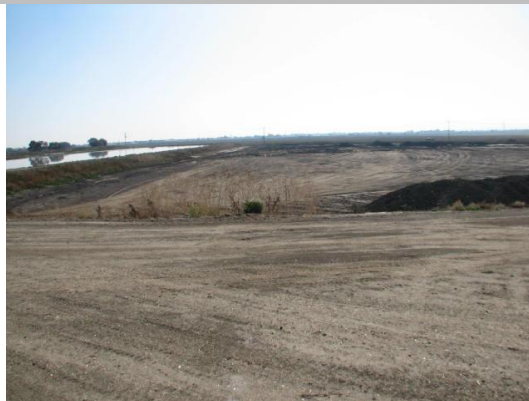
Photo 2 of 3 : mkhashch_s_20140428_00612.jpg

11/08/2011 Photo shows view from the levee looking to the left of the middle ramp.

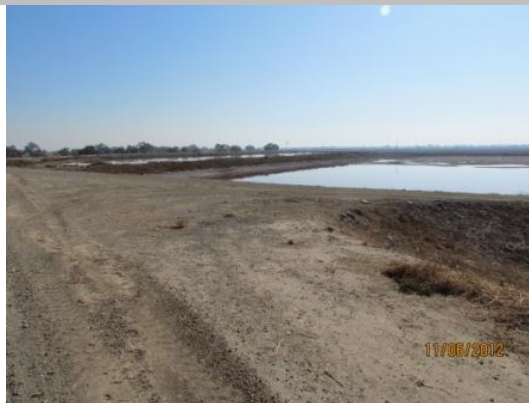
Photo 3 of 3 : mkhashch_s_20140428_00613.jpg

Completed new ramp constructed by Dairy farmer connecting his barns to the levee.

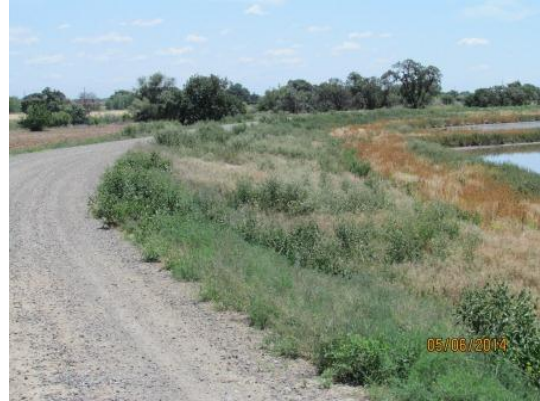
Photo 1 of 1 : mkhashch_s_20140512_00985.jpg

LM Start	5.41	Rating **	M	Issue No.	302
LM End	5.41	Issue Type +	Ma	Location *	LS
Category	Earthen Levee			GPS Latitude/Longitude	
				Start	End
Item	Vegetation			37.782185 °	37.782185 °
				-121.341480 °	-121.341480 °
DWR ID	DWR_RD2058_01_s _ 2014_302				
Action/Comments					
Control annual grass and weeds on the levee slopes and easements.

View of the tall vegetation on the landside levee slope obstructing visibility and access.
